Two Approaches to Rehabilitation of Metal Roofing at Wheeler Army Airfield Hawaii

Dave Bailey

U.S. Army Corps of Engineers,
Engineer Research and Development
Center

Construction Engineering Research
Laboratory
Champaign IL

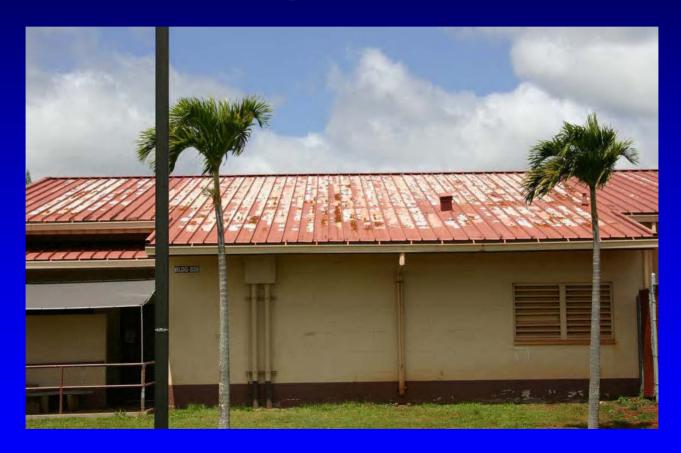
Existing Conditions

- Severe paint delamination
- Areas of rusting on panel surfaces
- Poor detailing of roof penetrations
